Power Transformer Condition Monitoring and Life-Cycle Management

Experience from a Detailed Case Study

Richard Heywood
Matthias Boltze
Sacha Markalous
Carl Johnstone

POWER TRANSFORMER CONDITION MONITORING AND LIFE-CYCLE MANAGEMENT

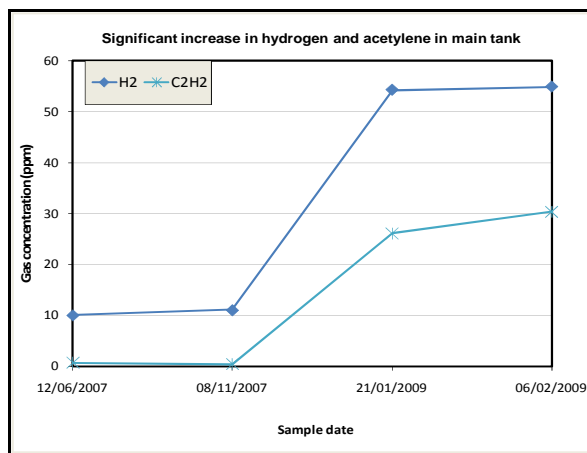
Figure 1
DGA increase in the main tank

The oil results in January 2009, as shown in the graphical form in Figure 1, showed a significant increase in acetylene to 26 ppm from trace (<1ppm), and the follow-up sample not only confirmed the high level of acetylene but also showed a further increase to 30 ppm within two weeks. The rise in acetylene was accompanied by an increase in hydrogen and rather more modest increases in levels of the other hydrocarbon gases. Such a DGA signature is typical of an arcing/sparking fault in the main tank of a power transformer. It was then decided to carry out a PD survey to confirm the critical transformer.

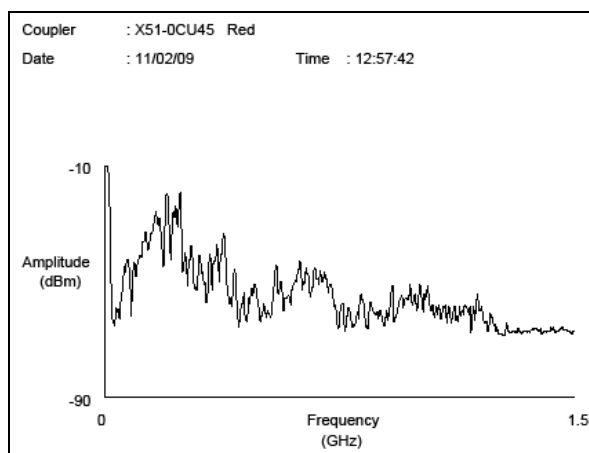
Figure 2
UHF PD survey, A/red phase

Partial Discharges were seen across all three phases at the coupling point, located on the HV side of the transformer, as shown from Figure 2 (red), Figure 3 (yellow) and Figure 4 (blue). The highest activity appeared to be from the yellow phase. Note little PD activity was picked up from the 400kV GIS switchgear building, at the circuit breaker end, and no PD activity was seen on the other side of the circuit breaker (bus bar end). This strongly suggested that PD activity was not in the GIS but inside the 750MVA transformer.

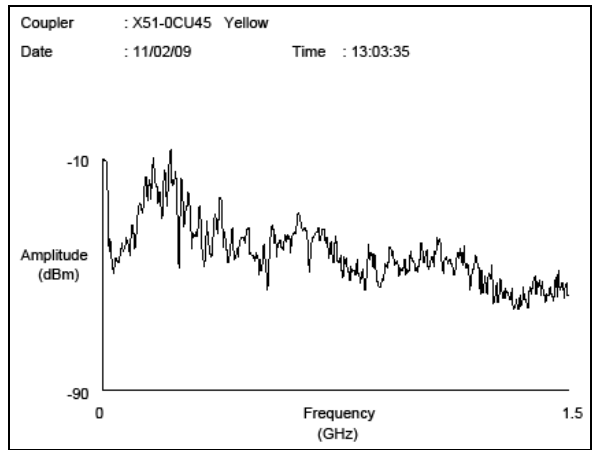
Figure 3
UHF PD survey, B/yellow phase

Further investigation was made to localise where the PD was emanating from the transformer T6607. The PD source appeared to be coming from the yellow phase (middle phase) on the HV side of the main tank. It was then decided that further tests should be carried out on the transformer T6607 to identify and localise the problem. An internal visual inspection should also be carried out in order to identify the problem. The transformer should only be put back in service after the problem has been found and rectified.

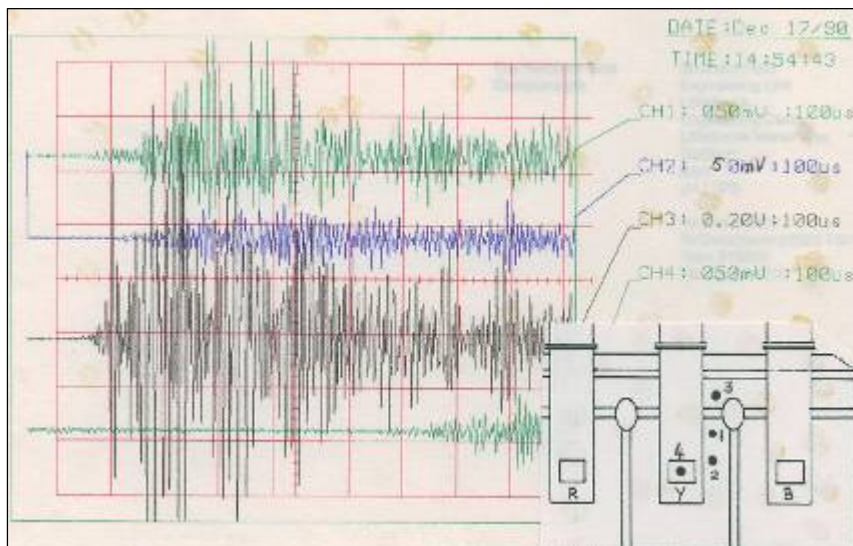
Figure 5
AE PD location in a sister transformer in December 1990

Figure 5 shows acoustic emission traces from the sister transformer, which had the same issue in late 1990 and had been re-clamped to fix the problem. It clearly shows that the largest activity is coming from near the main tank flange, i.e. top of the windings where the clamping bolts would be located.

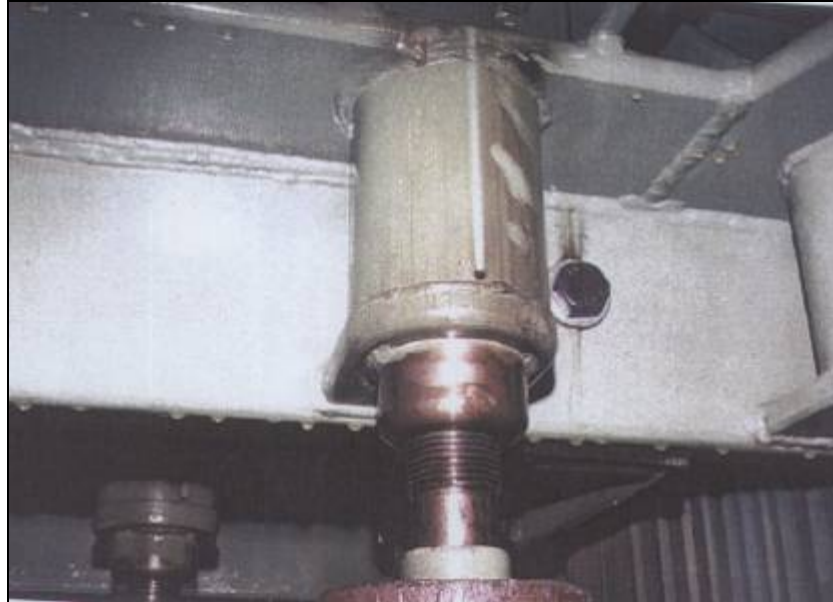
Figure 6
Photo from 2001 inspection of the transformer with carbon marks

The maintenance records showed that the transformer T6607 had been re-clamped in March 2001, after serious PD activity was located around the top flange on the HV side. During the internal inspection in 2001, it was found that most of the coil clamping bolts were loose with evidence of discharge activity, as shown in Figure 6, and the two outer bolts on the HV side of the middle phase were the worst affected.

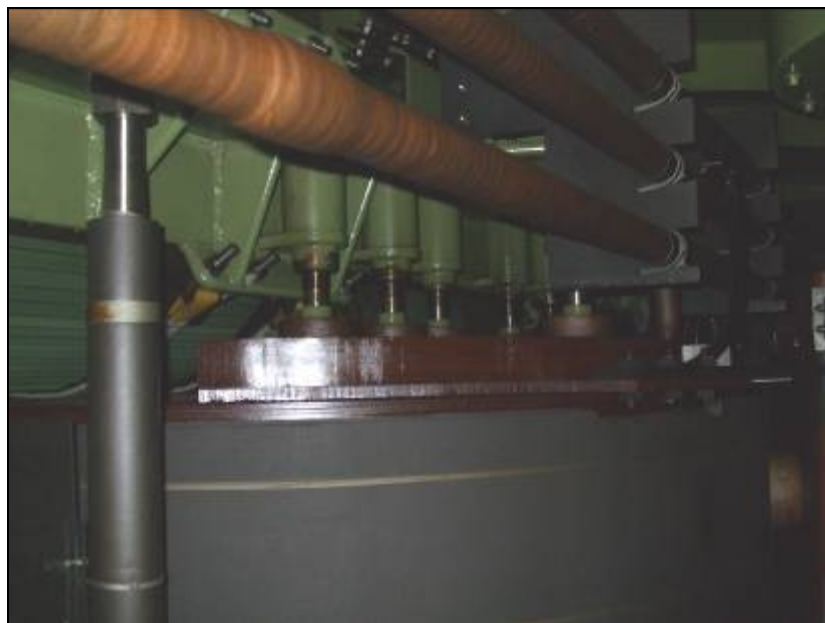
Figure 7
Photo from 2007 inspection, B/yellow phase HV side clamping bolts

were visibly inspected through panels on the A phase HV turret, the C phase HV turret and the C phase LV turret. They all seemed to be tight and there was no evidence of any arcing/sparking noted. Figure 7 shows a photo from 2007 internal inspection on B/yellow phase HV side clamping bolts.

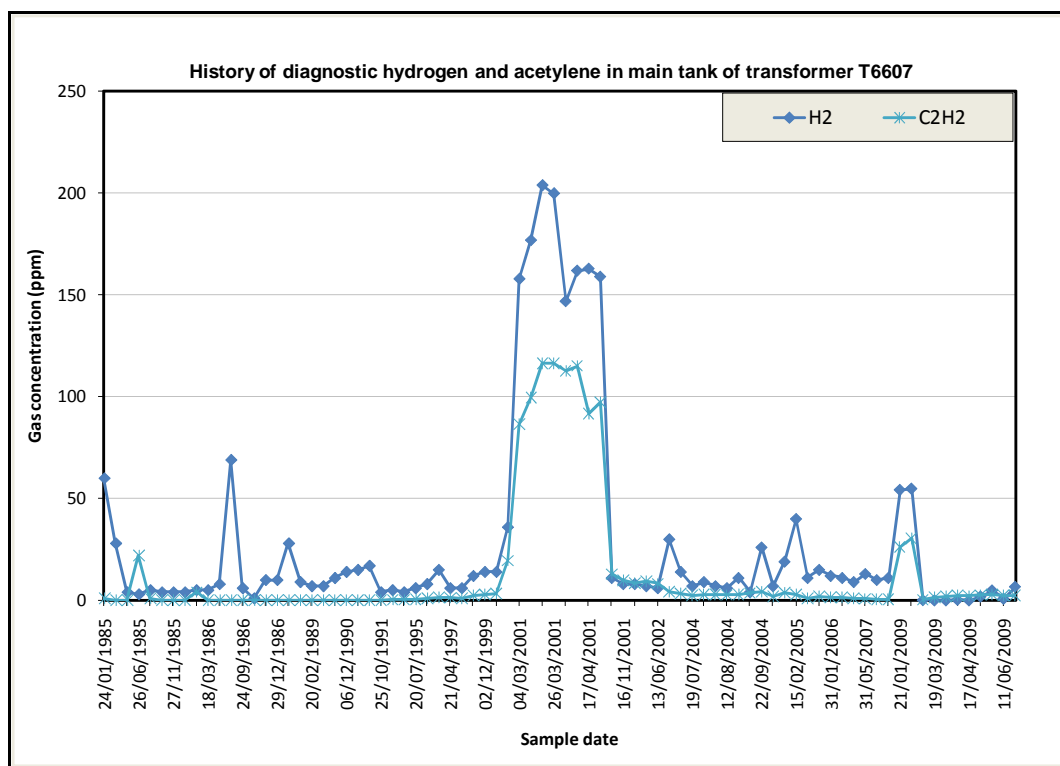
Figure 8
Acetylene and hydrogen history in main tank of the transformer T6607

Dissolved gas results for this transformer are available from 1985. The diagnostic acetylene and hydrogen history is shown in graphical form in Figure 8. The dissolved gas signature is illustrated in Figure 9. Some unusual results were obtained early in the life of the transformer – 22 ppm of acetylene was found in one sample taken in June 1985. There followed a period of some years when hydrocarbon gas levels were low and steady. Traces of acetylene were found in the main tank from July 1993, with levels rising gradually to 3.3 ppm in April 2000. The acetylene level then rose rapidly to a peak of 116.3 ppm in March 2001. This signature is typical of an arcing/sparking fault. After the loose clamping bolts had been re-tightened in April 2001, the acetylene level had since fallen gradually from 12.9 ppm in October 2001 to less than 1.0 ppm in 2007. The significant increase in acetylene to 26 ppm in January 2009 was very much similar to that of March 2001 although the relatively lower acetylene level implies that most likely some of the clamping bolts were loosening again.

As shown in Figure 8, the acetylene level in main tank of the investigated transformer T6607 had fallen to trace levels (less than 3.0 ppm) since the return to service, which confirmed the success of retightening the loose clamping bolts.

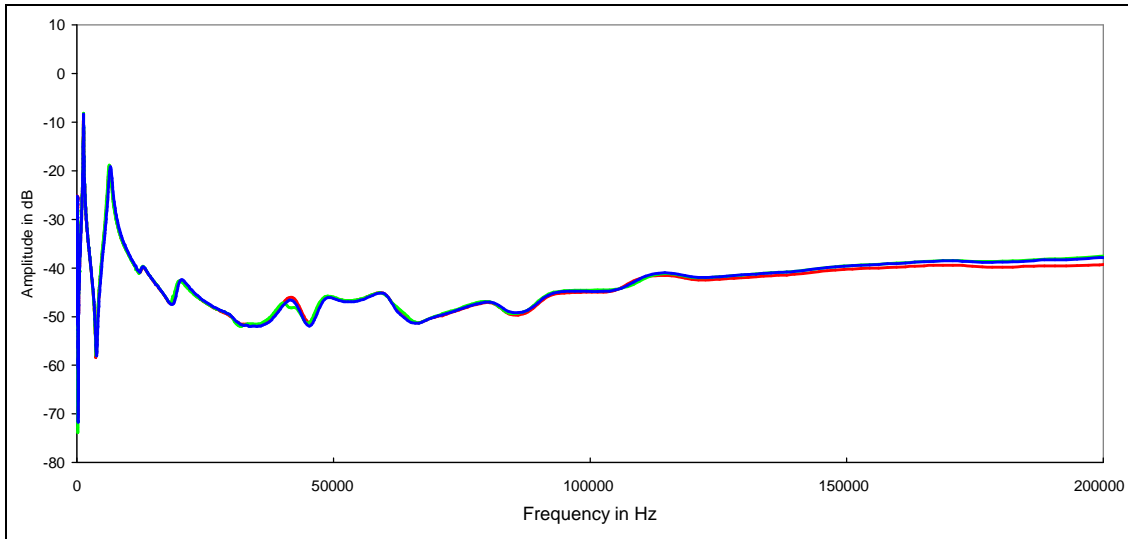
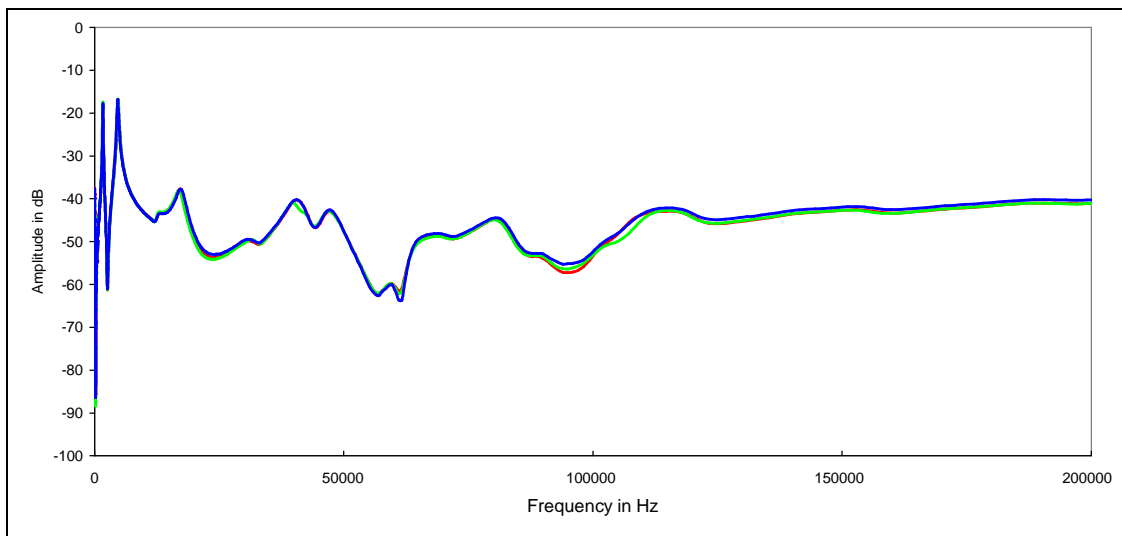
Measured winding frequency responses, as partly illustrated in Figure 10 and Figure 11, were in very good agreement between phases and with previous 2001 results, with no indication of any significant winding movement. It was safe to say that the increase in acetylene in the main tank as well as the picked up discharge activity is most likely due to the winding clamping becoming loose again, possibly as a result of the LV cable fault on the attached circuit in late 2008.

It was therefore decided that an internal investigation of the transformer T6607 should be carried out to check the winding clamping arrangements and retighten any loose clamping bolts.

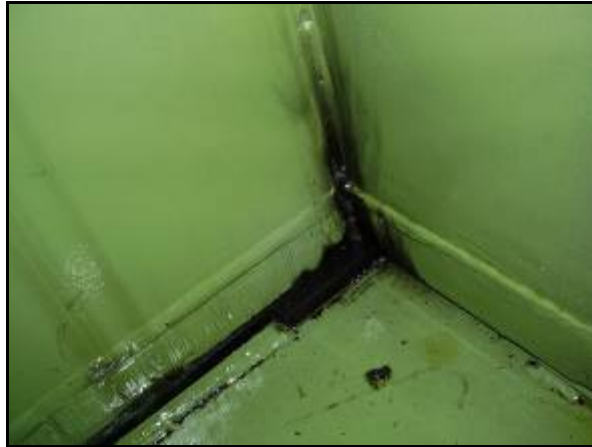
Figure 12
HV red phase inside corner

During the internal inspection of the transformer T6607 in late February 2009, it was found that some of the winding clamping bolts in the HV side were loosening with evidence of discharge activity, as shown in Figure 12 and Figure 13. The transformer was therefore re-clamped by retightening the loosened clamping bolts. The oil was also reprocessed before the transformer was returned back in service.

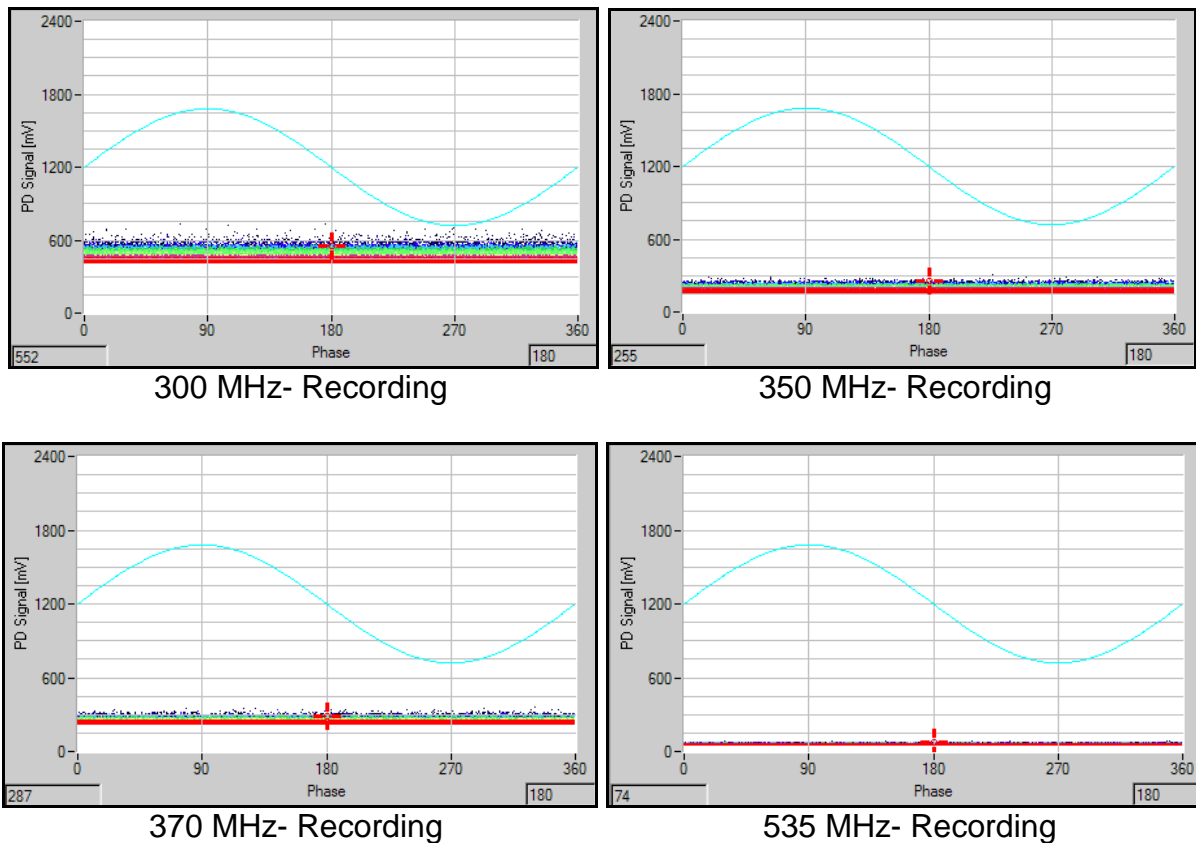
Figure 16
Results of the frequency selective measurements

Results of the frequency selective measurements at 300 MHz; 350 MHz; 370 MHz and 535 MHz are shown in Figure 16. No PD levels above the detection sensitivity had been measured. Based on the UHF PD survey results the investigated transformer T6607 was assessed PD-free under operation voltage considering the recorded background noise level.

It was then decided that the transformer should be returned to service with online GIS PD monitoring plus enhanced oil sampling for further assessment.
