Power Transformer Condition Monitoring and Life-Cycle Management

Experience from a Detailed Case Study

Richard Heywood
Matthias Boltze
Sacha Markalous
Carl Johnstone

POWER TRANSFORMER CONDITION MONITORING AND LIFE-CYCLE MANAGEMENT

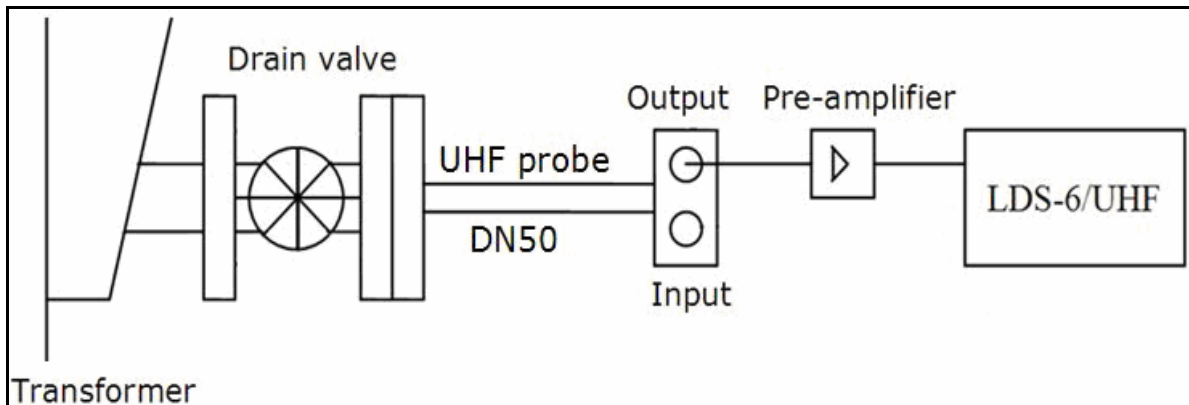
Figure 14
Schematic diagram of the PD measuring setup on the power transformer

The UHF PD survey was carried out with Doble LDIC's PD Measuring System LDS-6/UHF. The main parts of this PD measurement system are the UHF probe DN50, a pre-amplifier and the measuring instrument LDS-6/UHF. The measuring system as a whole is illustrated in Figure 14. A close up of the applied UHF drain valve sensor and LDS-6/UHF measuring system are shown in Figure 15. The measuring frequency of the UHF Processing Unit in this system is adjustable in the frequency range from 110 MHz to 1700 MHz with a frequency
